DEPARTMENT OF PLANNING AND DEVELOPMENT

STAFF REPORT
ITEM NO. One.

ADDRESS: *113 E 9th Street*

COA REQUEST: *Demolition of Structure*

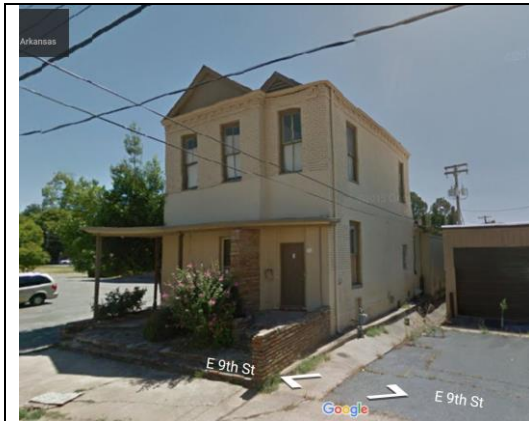
Google Street view of north and west elevation

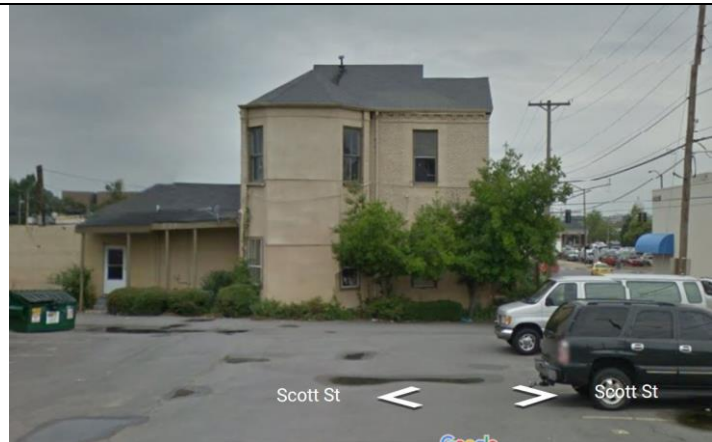
Google Street view of east elevation

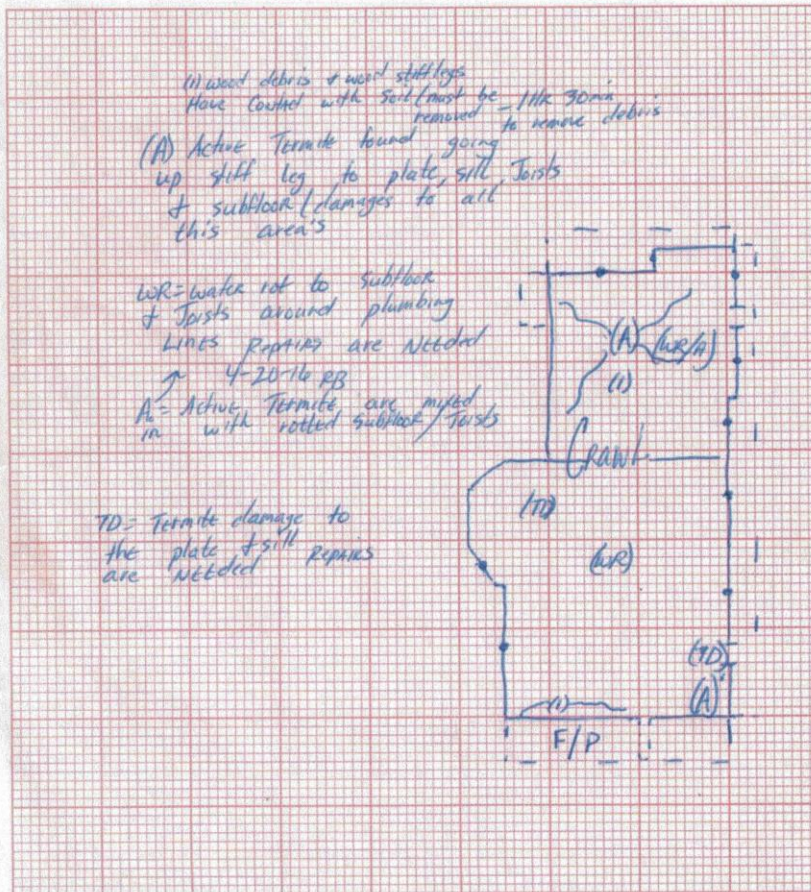
Sketch from Curry's Pest Control

The applicant has provided two pieces of documentation concerning the condition of the structure. The first is from Curry's Pest control that states that there is active termite activity occurring in two locations of the building noted by (A) on the plan. There are also notes of water rot to subfloor and joists around plumbing lines. Termite activity is also noted in those areas of rotted joists and subfloors. There is old termite damage to the plate and sill on the west wall. On the cover letter, it states that these areas will require extensive repairs.

The results of our inspection show termite activity up the stiff leg to the plate, sill, joists and subfloor. All of these areas have damage and in our opinion need extensive repairs. There is water rot around all plumbing areas with damage to subfloors and joists which all are needing repairs. Wood debris throughout crawl also needs to be removed.
