MACARTHUR PARK **LITTLE ROCK**

HISTORIC DISTRICT
DESIGN GUIDELINES

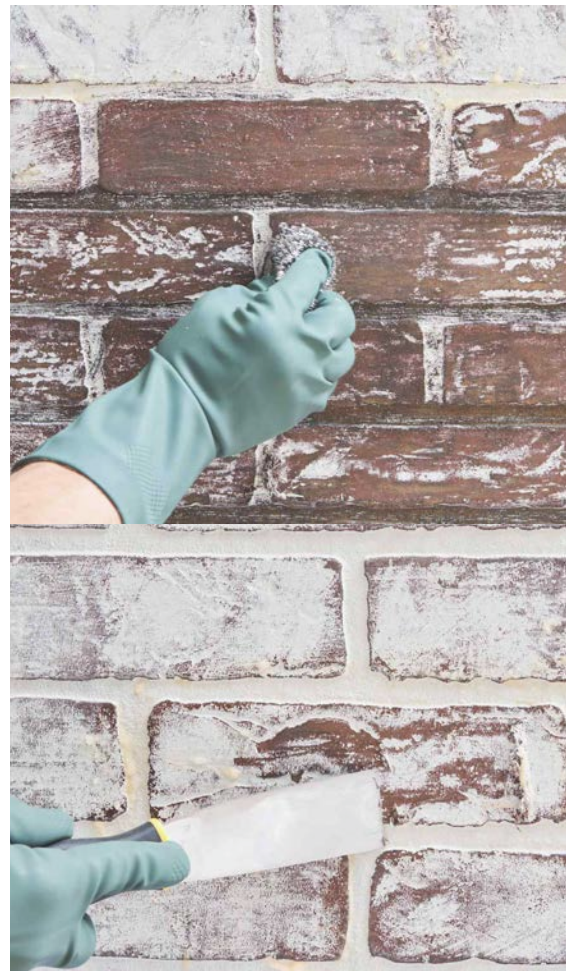
Clean and remove paint from masonry surfaces using gentle scraping methods. © The Spruce

- 1. Remove oil and metallic stains using non-ionic detergents or other appropriate commercial products.
- 2. Use biodegradable or environmentally safe cleaning or paint removal products.
- 3. Consult a skilled mason knowledgeable in historic masonry to remove paint from masonry surfaces using chemical removers.
- 4. When cleaning or removing paint from masonry surfaces, prepare a test area with low visibility to determine which cleaning methods are appropriate and safe to prevent discoloration or further damage.
- 5. When repainting existing painted masonry, use a hand scraper to remove the outer layer of paint prior to repainting with water permeable paint following the manufacturer's instructions. Latex paint seals moisture inside masonry causing deterioration and is not appropriate for use on masonry materials.

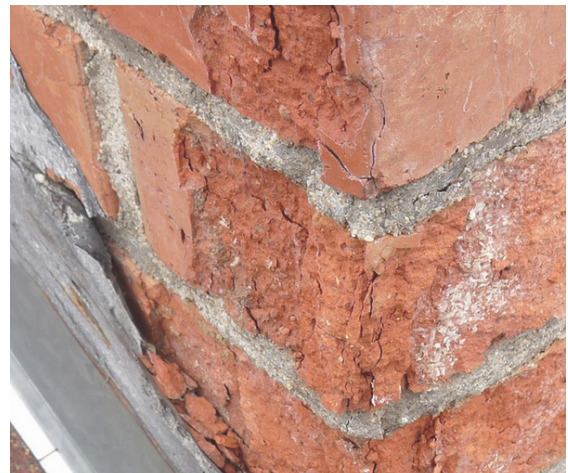
Do not use portland cement as a type of mortar, as this will cause spalling. © Hudson Valley Chimney

- 1. Do not use concrete or Portland cement to replace historic mortar joints if not used originally. Concrete and Portland cement will not expand and contract when needed, causing masonry to crack.
- 2. Match the new mortar to the original mortar material in composition, strength, color, and texture. Duplicate the width and joint profile of historic mortar joints to avoid altering the character of the building when viewed from the street.

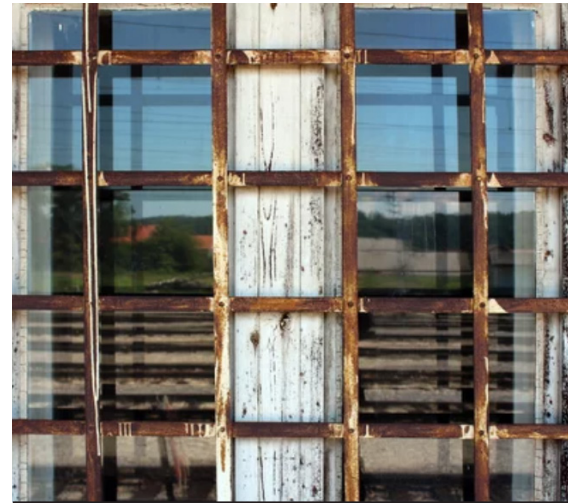
Do not ignore rusted metal features. Consult with an experienced contractor if the rust is heavy.
© Adobe Stock

- 1. Use a lacquer coating to protect soft metals, such as unpainted bronze.
- 2. 3.Protecting cast iron architectural features with an oil-based alkyd paint is an appropriate method of preservation. Before painting, use a corrosion-inhibiting primer on iron features immediately following cleaning to avoid new rust forming.

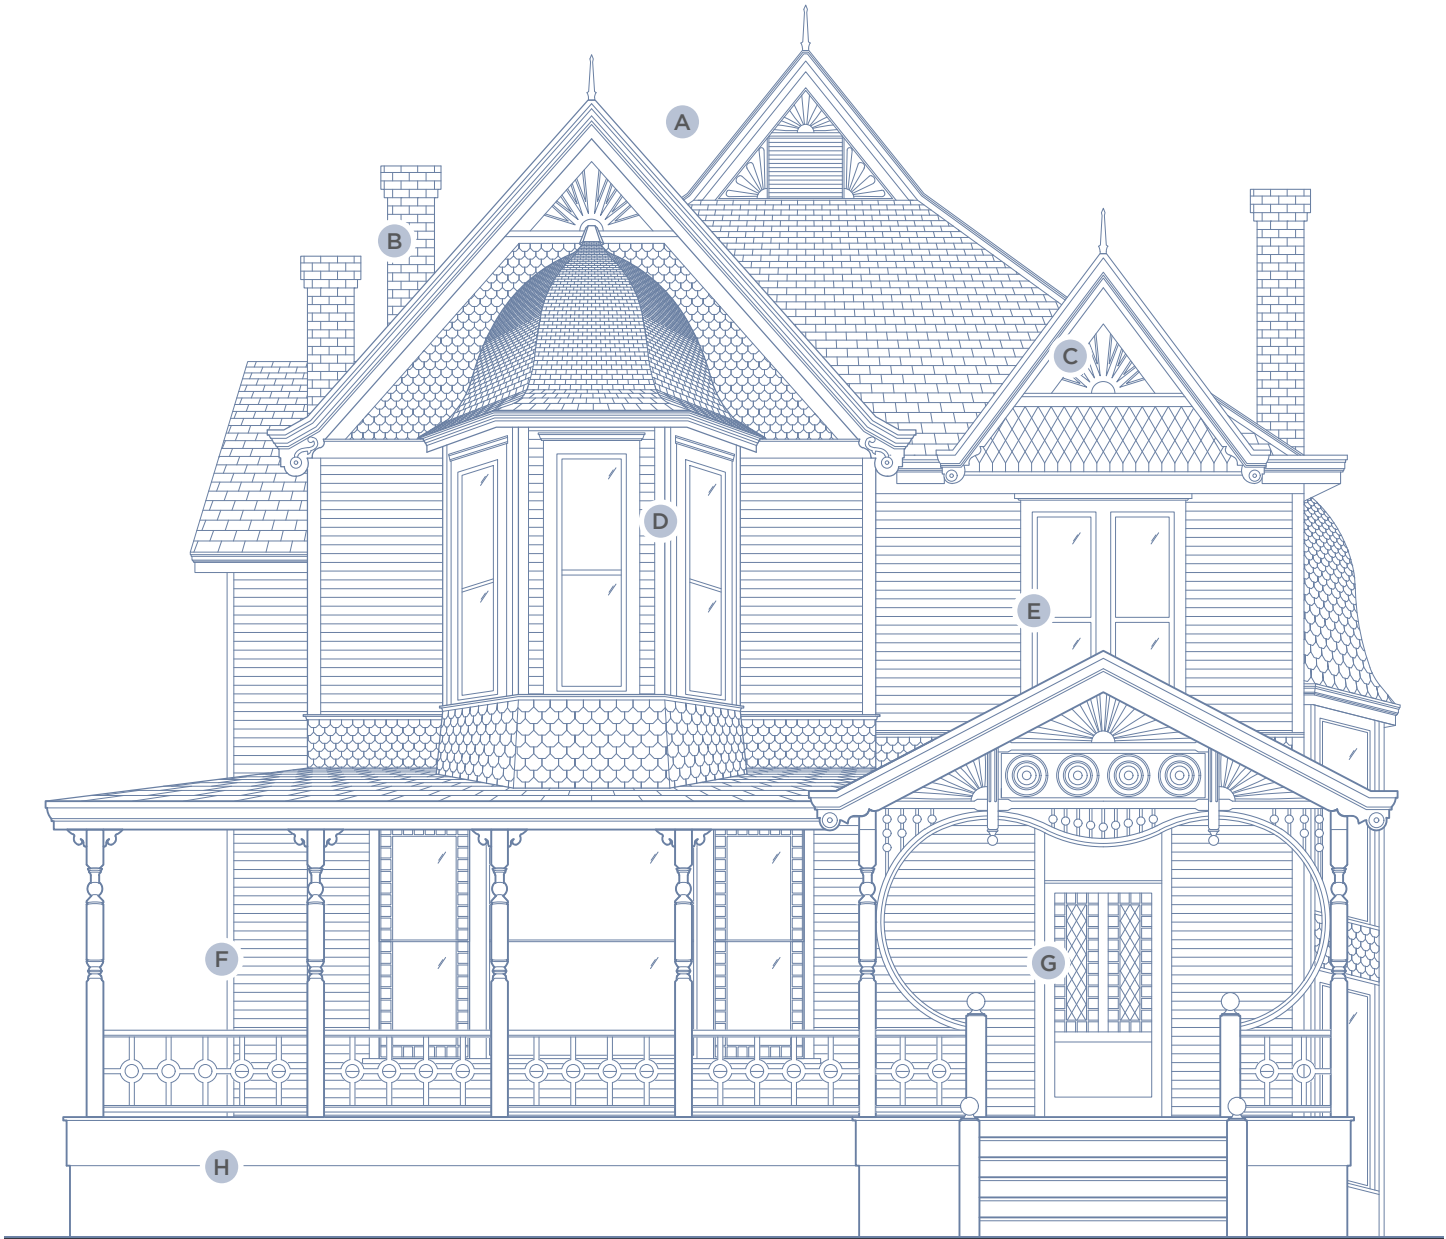
- A. Roof Elements
- B. Chimney
- C. Decorative Features
- D. Bay Window

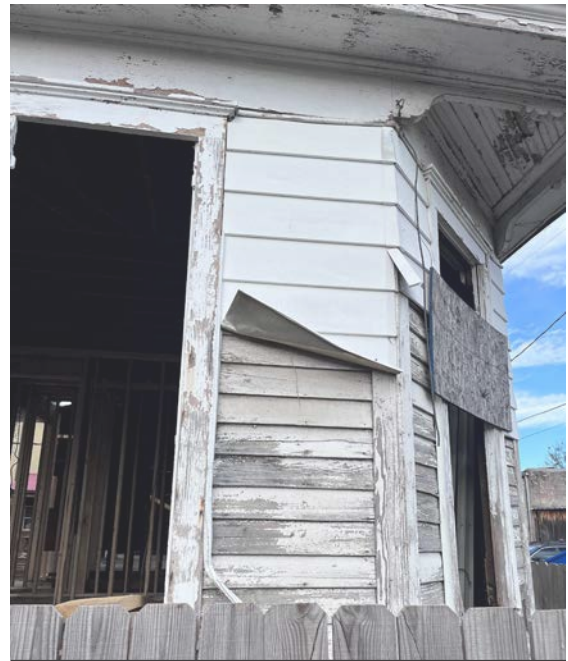
Remove existing artificial siding to uncover historic wood siding, 112 W. 13th St.

4. Remove existing artificial siding to uncover historic wood siding. Repair and repaint the uncovered wood siding as needed.

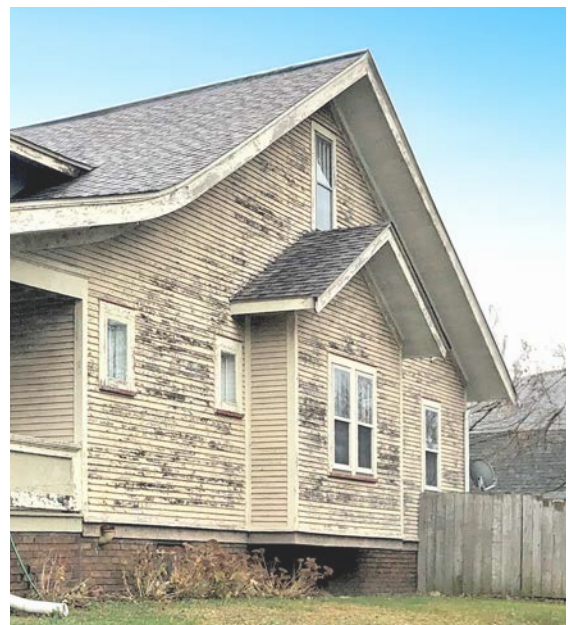
Use hand scrapers to remove peeling or blistered paint prior to repainting.

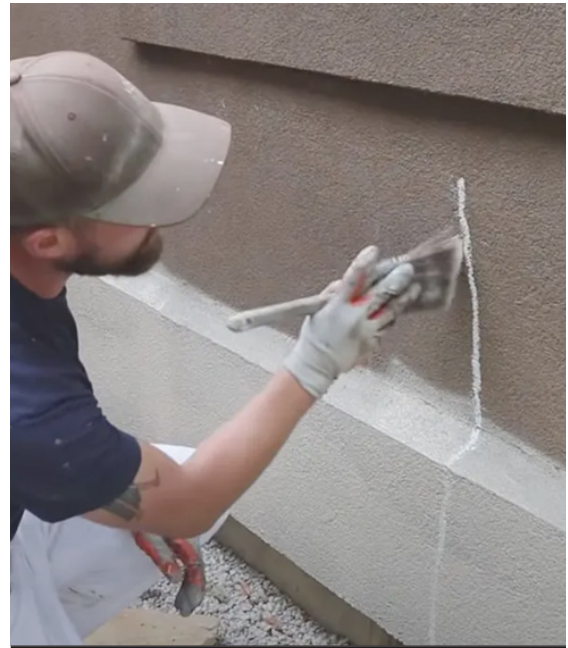
Use paint or limewash to repair small cracks in historic stucco.
© Tape University

1. Do not cover or repair historic stucco with synthetic stucco such as Exterior Insulation and Finish Systems (EIFS) or other modern materials such as vinyl or aluminum siding.
2. Do not repair historic stucco using modern concrete mixes.
3. Patch broken or deteriorated areas of stucco with new stucco matching the original in composition, texture, and color.
4. Use paint or limewash to repair small cracks in historic stucco to strengthen the wall surface and prevent the cracks from expanding.
5. Install control joints when repairing large areas to avoid future cracks.

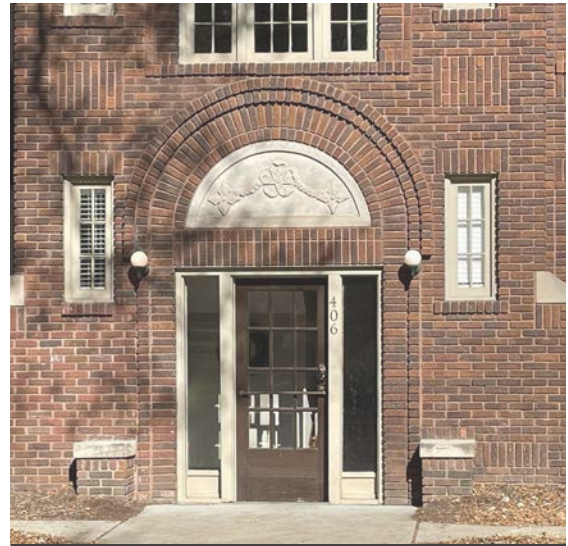
Repair deteriorated or missing mortar joints in masonry door surrounds to prevent water infiltration, 406 E 7th St.

- 1. Repair rather than replace deteriorated historic doors, including door openings, hardware, door surrounds, sidelights, transoms, muntins, and glazing.
- 2. Use wood epoxies to repair areas of damaged wood and scrape away peeling or blistering paint or stain prior to repainting or re-staining.
- 3. Repair deteriorated or missing mortar joints in masonry door surrounds to prevent water infiltration.

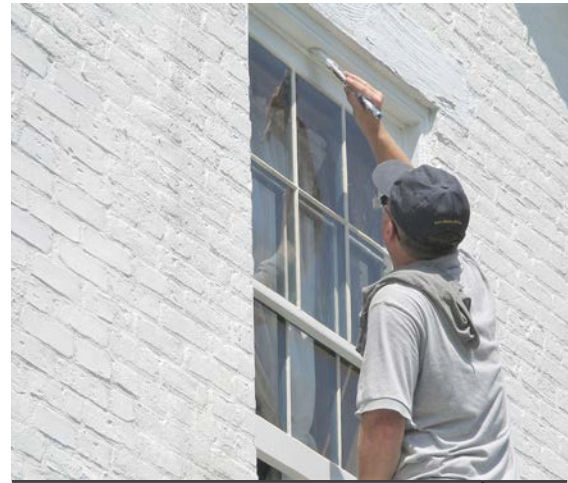
Scrape and repaint historic windows to protect wood from deterioration.
© Indiana Landmarks

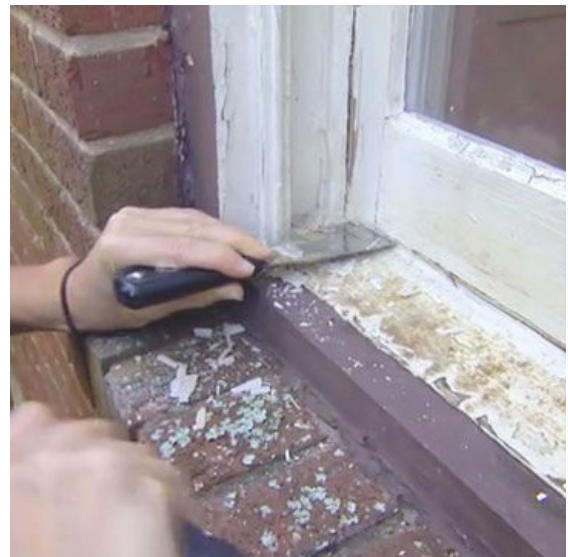
Carefully cut through the paint seal when reopening a window that is painted shut.

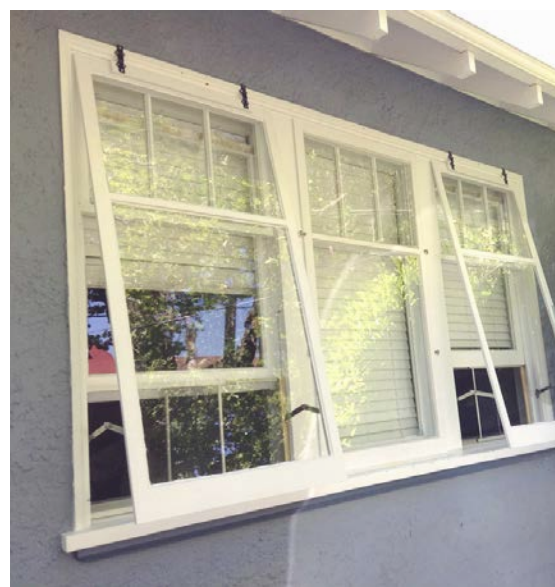
Add storm windows as a second barrier against the elements and air infiltration. © Spenser Works

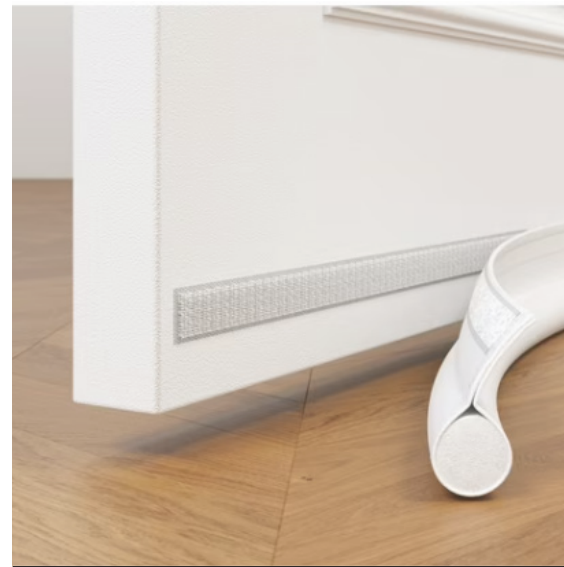
Door sweeps or drafter stoppers can be added to fill the gap at bottom of a door. ©Walmart

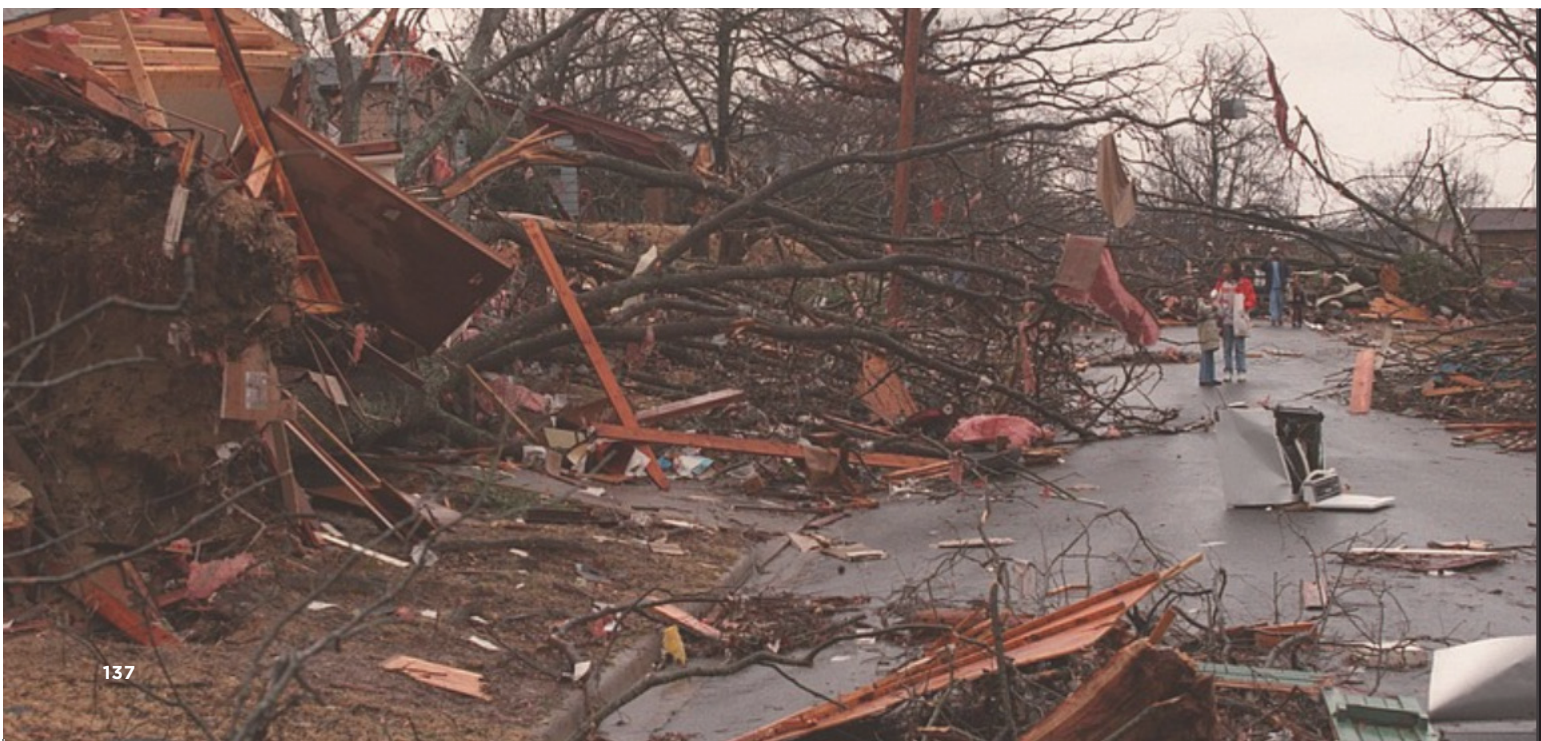
Damage resulting from the 1999 tornado in Little Rock. © Arkansas Online

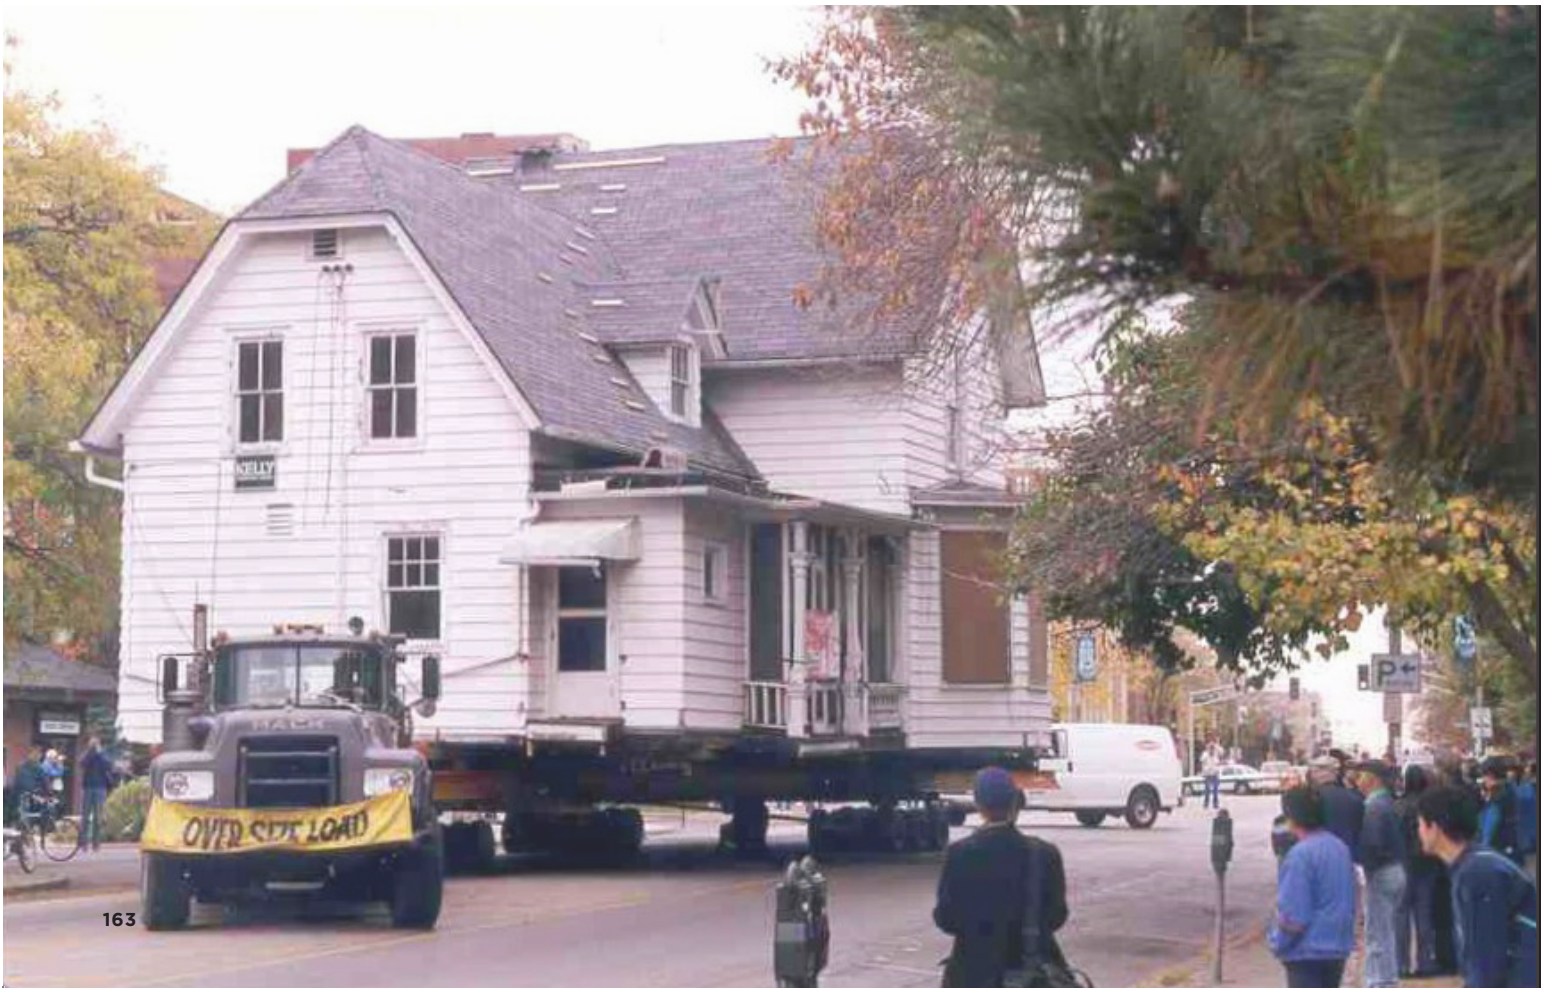
Relocation of a historic house. © Village of Oak Park, IL
